MATERIAL CHARACTERIZATION AND OTHER THICKNESS DESIGN
CONSIDERATIONS FOR AIRFIELD PAVEMENT RUBBLIZATION

PRESENTED FOR THE
2007 FAA WORLDWIDE AIRPORT TECHNOLOGY TRANSFER CONFERENCE
Atlantic City, New Jersey, USA

This paper is based on preliminary work done under Airfield Asphalt Pavement Technology Program Project (AAPTP) 04-01, “Development of Guidelines for Rubblization” [1]. While the project covers all design, construction and quality control aspects for rubblization of airfield concrete pavements, this paper focuses on thickness design considerations. Only the layered elastic design methodology is addressed in this paper, even though the project also addresses the CBR method for military airfield design. A large portion of this paper summarizes backcalculated moduli values of rubblized concrete layers from projects found in the literature (performed by other researchers). New backcalculations of FWD data from other rubblized projects were performed by the authors to obtain additional moduli. These values are summarized, analyzed and compared to recommended ranges of rubblized material published elsewhere. A relationship between rubblized modulus and slab thickness is examined.

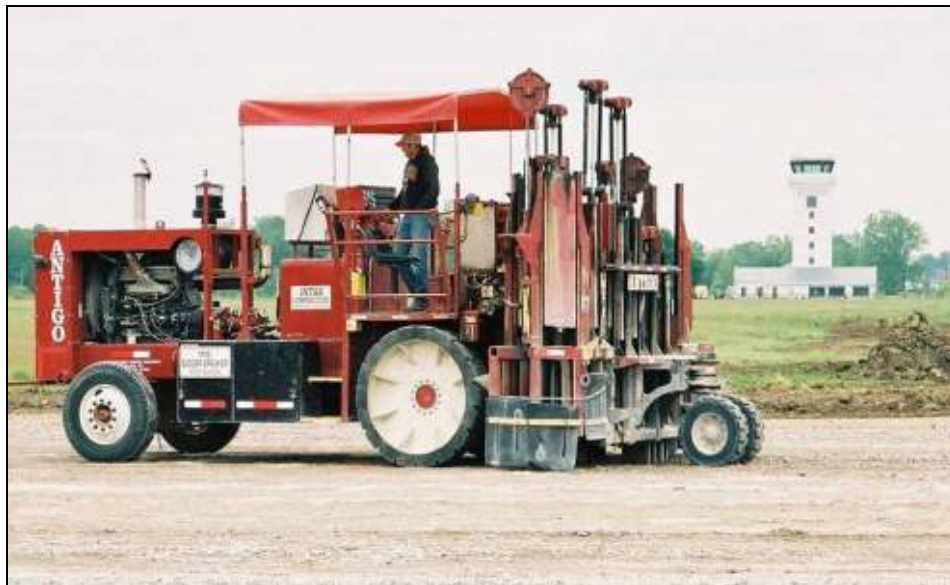
Figure 2. Multiple Head Breaker (MHB)

There are two basic types of rubblization equipment; the resonant pavement breaker (RPB) and the multi-head breaker (MHB). Both types can vary in size and weight depending on the model. The RPB is shown in Figure 1 and the MHB is shown in Figure 2. Fitts described the rubblization process with the RPB [2] while Thompson did the same with the MHB [3] at TRB in 2005. The RPB is a self-propelled breaking unit that produces low amplitude (1/2-1 inch), high frequency (42-46) impacts per second (hertz) through a massive steel beam, often described as a “giant tuning fork.” The vibrating foot rubblizes the concrete pavement in narrow strips as the machine moves forward along the unfractured edge of the pavement. The MHB is both a tractor and breaking unit, consisting of numerous pairs of 1,200 lb, 8-inch wide hammers

mounted laterally across the breaking unit that produces continuous breakage from side to side. Each hammer pair operates independently and develops between 1,000 and 8,000 foot-pounds of energy (depending upon the drop height selected) and cycles at a rate of 30 to 35 impacts per minute. The tractor travels on the unbroken slab as it moves forward and tows the breaking unit behind. Production rates for both the RPB and the MHB are generally from 6,000 to 8,000 yd² per unit per workday shift, with thick airfield pavements being on the low end of this range.

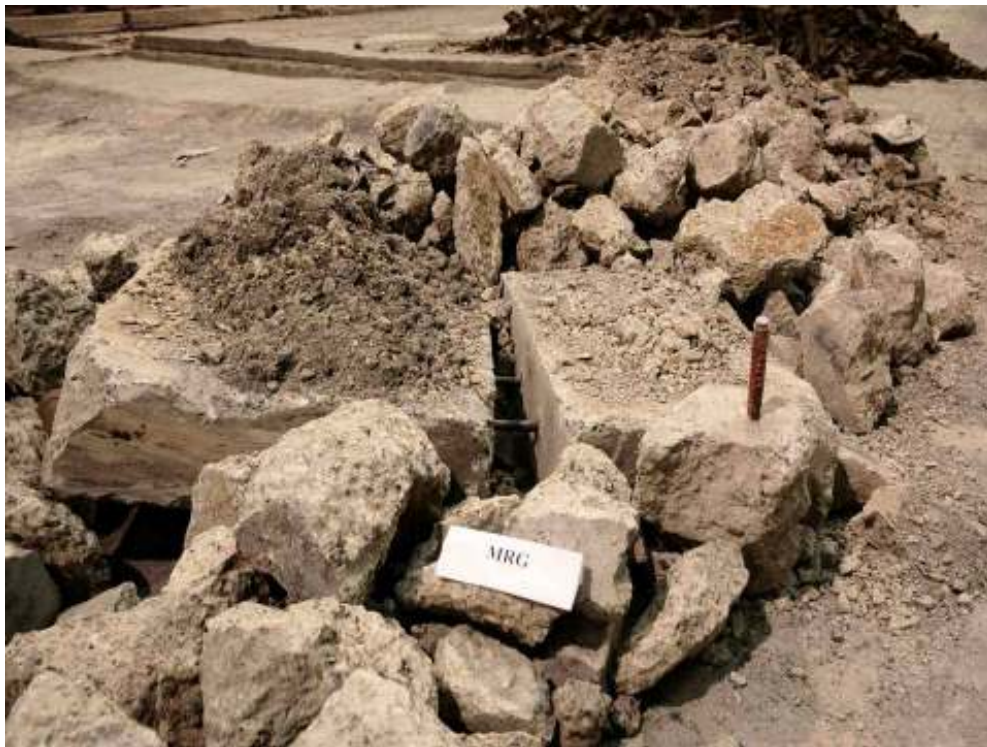
Figure 4. Excavated Rubblized PCC in MRG Section at NAPTF (15)

These average rubblized moduli are somewhat high compared to other projects of similar slab thicknesses. This may be explained by examining the typical rubblized material excavated from one of the post-trafficked trenches shown in Figure 4. The top 2-3" of the rubblized PCC was typically broken down to particle sizes of 1-inch minus, while the particle sizes in the bottom 9" of the rubblized layer typically had dimensions as large as 12 to 30 inches. The slabs were fractured full depth but not to the gradation limits typically required in most rubblization specifications. The fractures were hairline and there was a high degree of particle interlock below the top 3 inches of "crushed" material. NAPTF personnel estimated that approximately 80% of the dowels examined in the trenches remained bonded to the concrete.
